**Long-Term Surveillance Plan
for the
DOE Bluewater (UMTRCA Title II) Disposal Site
Near Grants, New Mexico**

July 1997

Prepared for
U.S. Department of Energy
Grand Junction Office
Grand Junction, Colorado

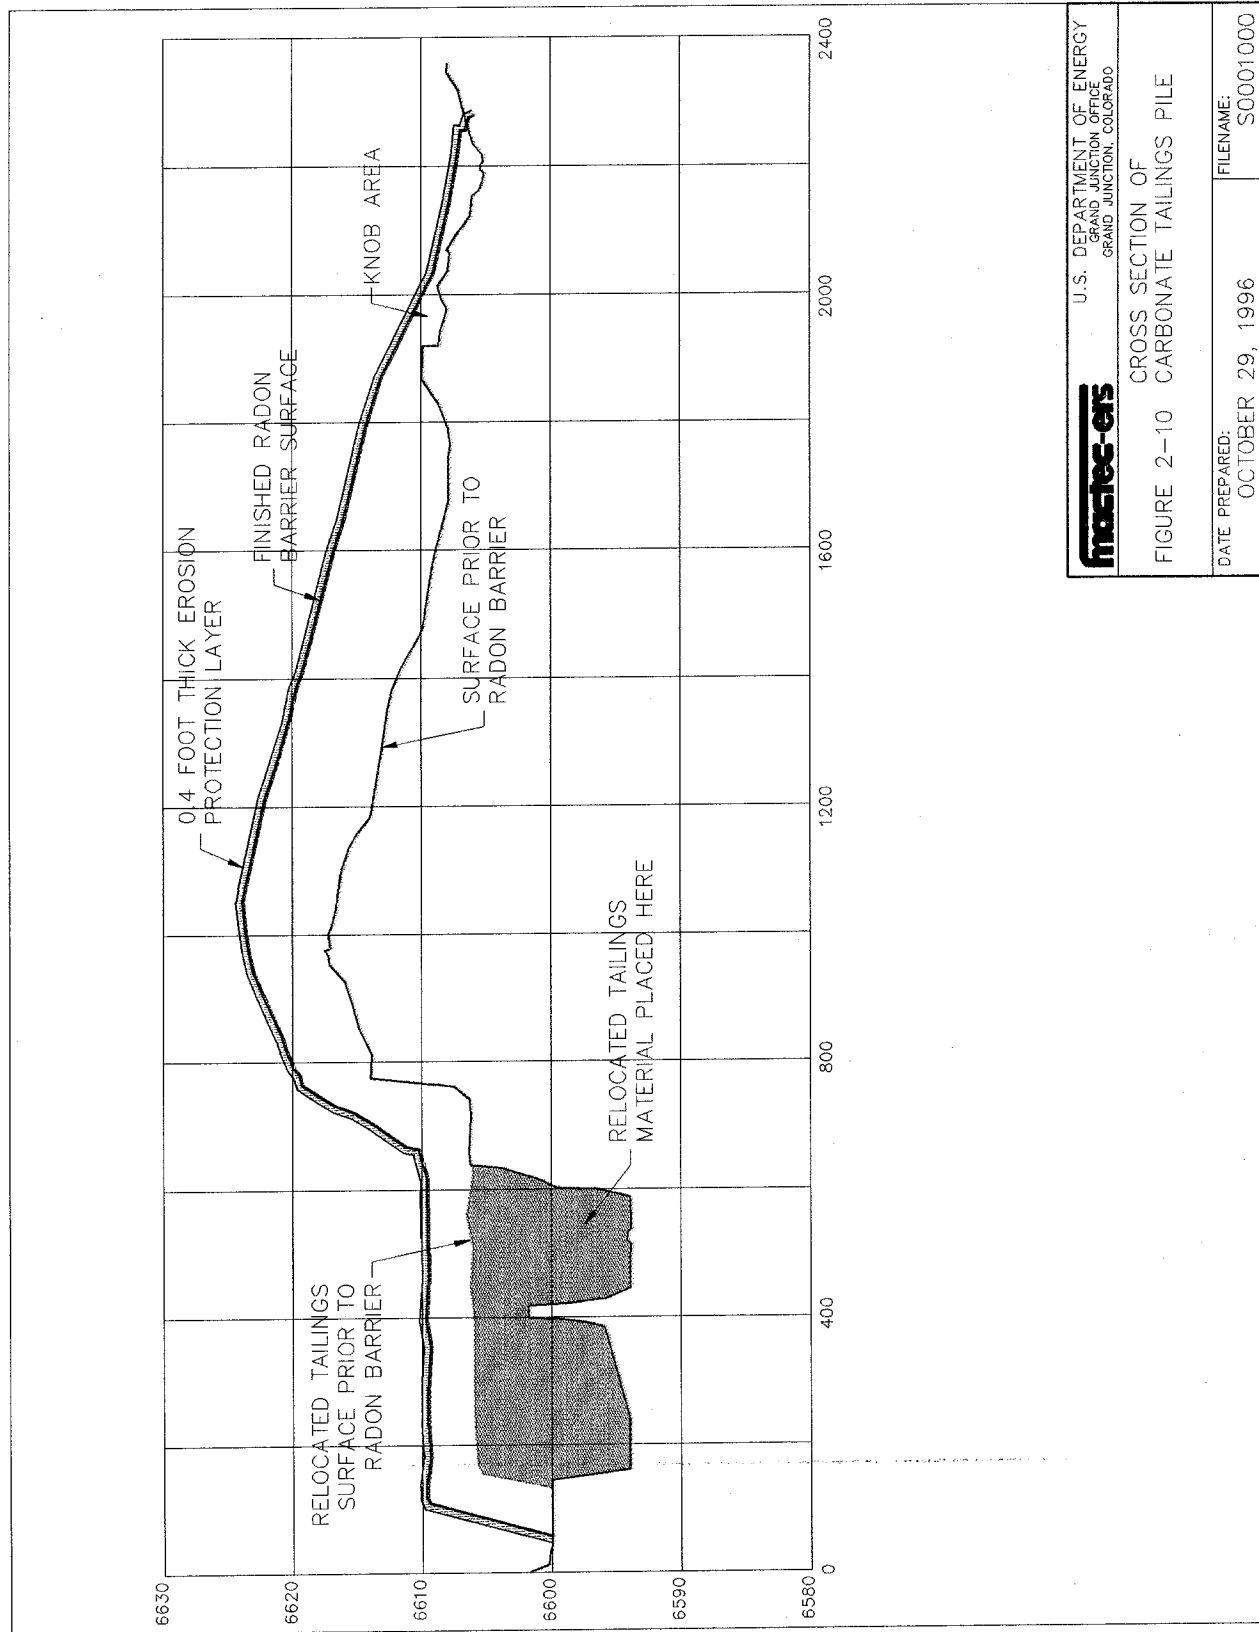
Figure 2-10. Cross Section of Carbonate Tailings Pile

pile—from 3.5 to 4 ft (1.1 to 1.2 m) in the main part of the pile to 2 ft (0.6 m) in disposal area no. 2 and 2.4 ft (0.7 m) in disposal area no. 3.

The carbonate tailings pile contains tailings generated from the carbonate leach process that were deposited just northeast of the plant site from 1953 to late 1955. The carbonate pile shown in Figure 2-9 includes disposal areas no. 2 and no. 3, both of which were used for disposal of mill building debris, evaporation pond liner, and other rubble. Disposal area no. 2 is in the south part of the carbonate pile and disposal area no. 3 is in the southwest part of the pile. A typical cross section through the carbonate pile is shown in Figure 2-10.

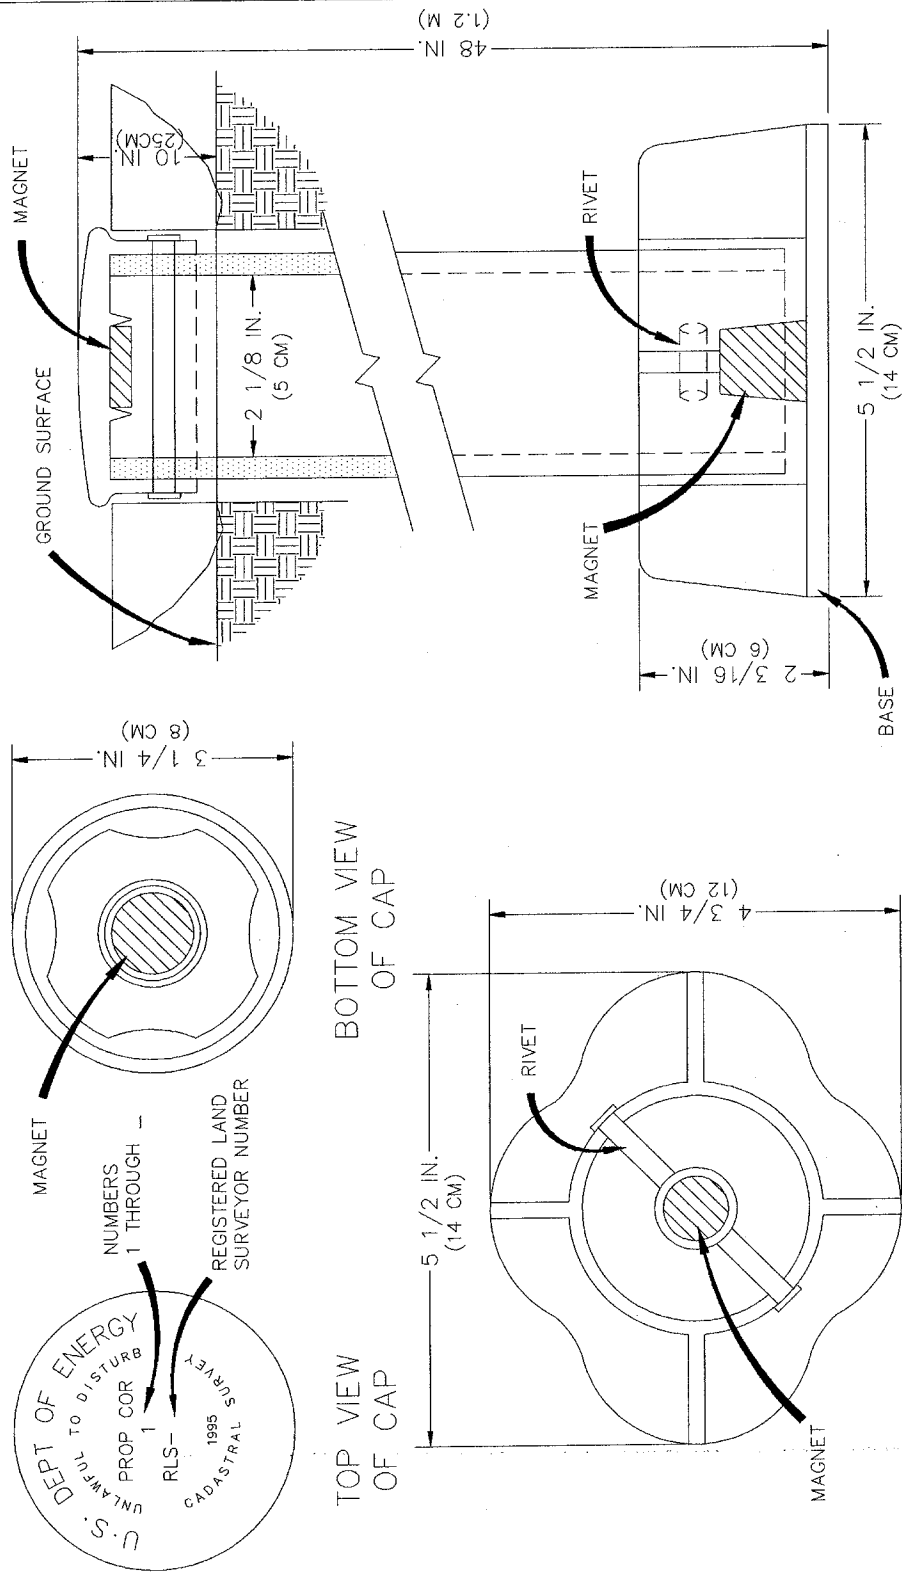
Figure 2-11. Boundary Monument at Bluewater, New Mexico, Site

BERNTSEN FEDERAL ALUMINUM BOUNDARY MONUMENT, MODEL A-1, STANDARD LOGO CAP

SCHEMATIC--NOT TO SCALE

Bernsten Federal aluminum survey monuments, Model A-1, were used for the 24 boundary monuments (Figure 2-11). Ceramic magnets are epoxied into the cap and base of each monument and are vertically oriented so that the monument can easily be found if it becomes buried. The monuments are set with the base 38 in. (97 cm) below ground surface and 10 in. (25 cm) above ground surface (Figure 2-11).

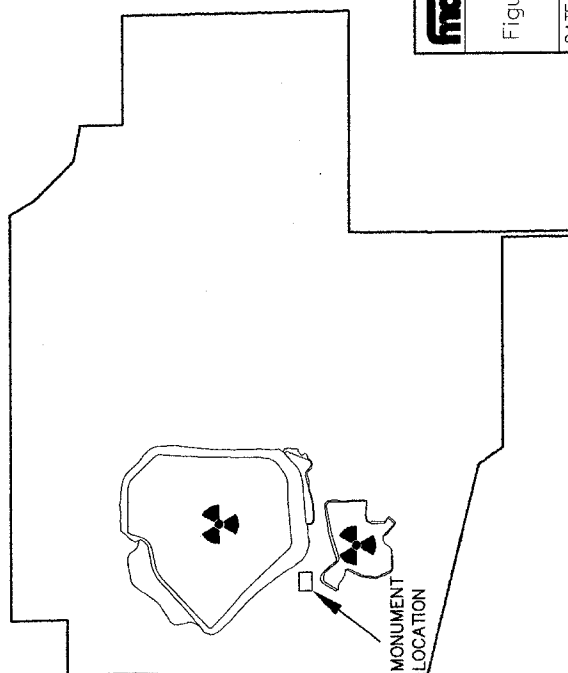
INCISED MARKER
Figure 2-14. AT BLUEWATER,
NEW MEXICO, SITE

MAIN TAILINGS 11,200 Curies, Ra-226
CARBONATE TAILINGS 1,130 Curies, Ra-226

The inscription on the site marker identifies the general locations of the tailings piles within the site property, the date of closure, the tonnage of tailings, and the curies of radioactivity of radium-226. The international symbol for radiation is also inscribed in the marker at the position of each tailings disposal area (Figure 2-14).
